**Galbraith School
Lethbridge School Division**

Visioning Session

Project ID 21072

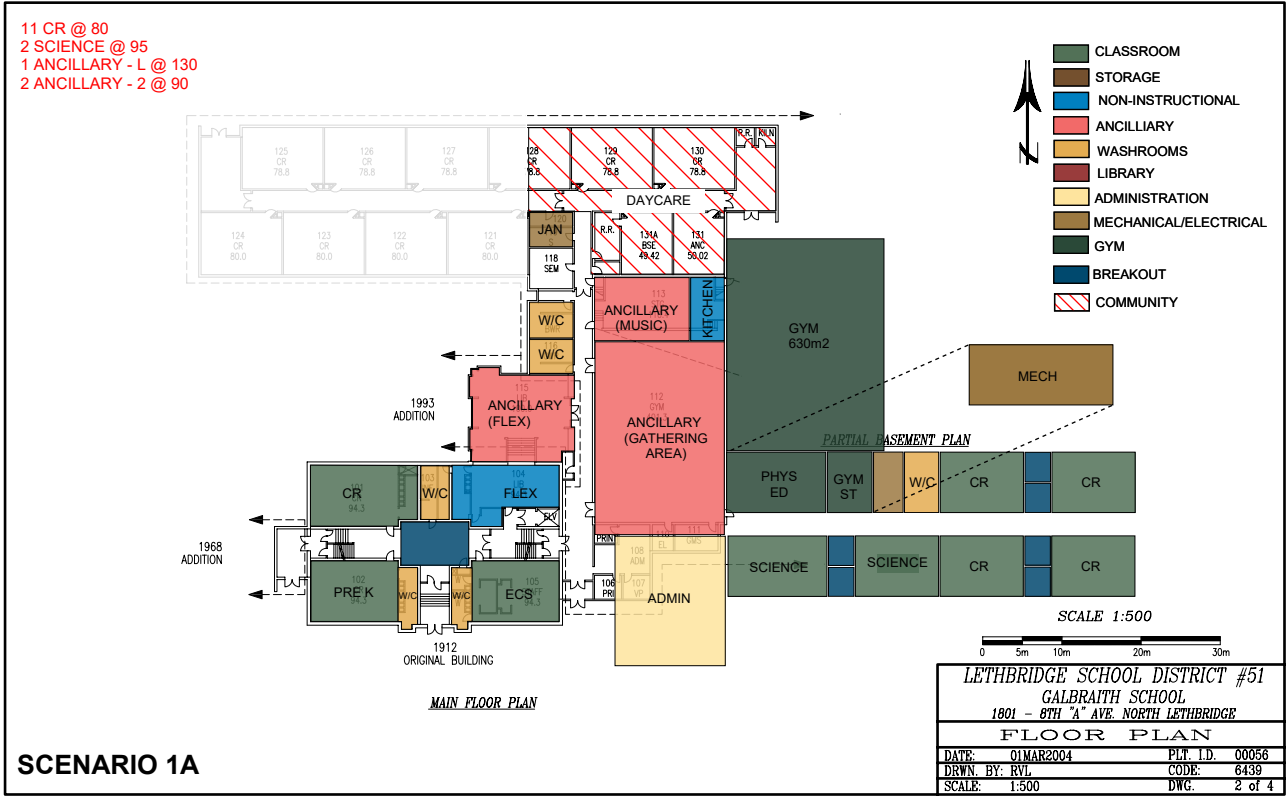
- The original administration area is replaced with an addition of a larger administration area and staffroom and creates a more spacious entrance with optimal visibility, alleviating the current concerns with the security and safety of students and staff.

- The second floor of the original space will be utilized as classrooms with the addition of washrooms.

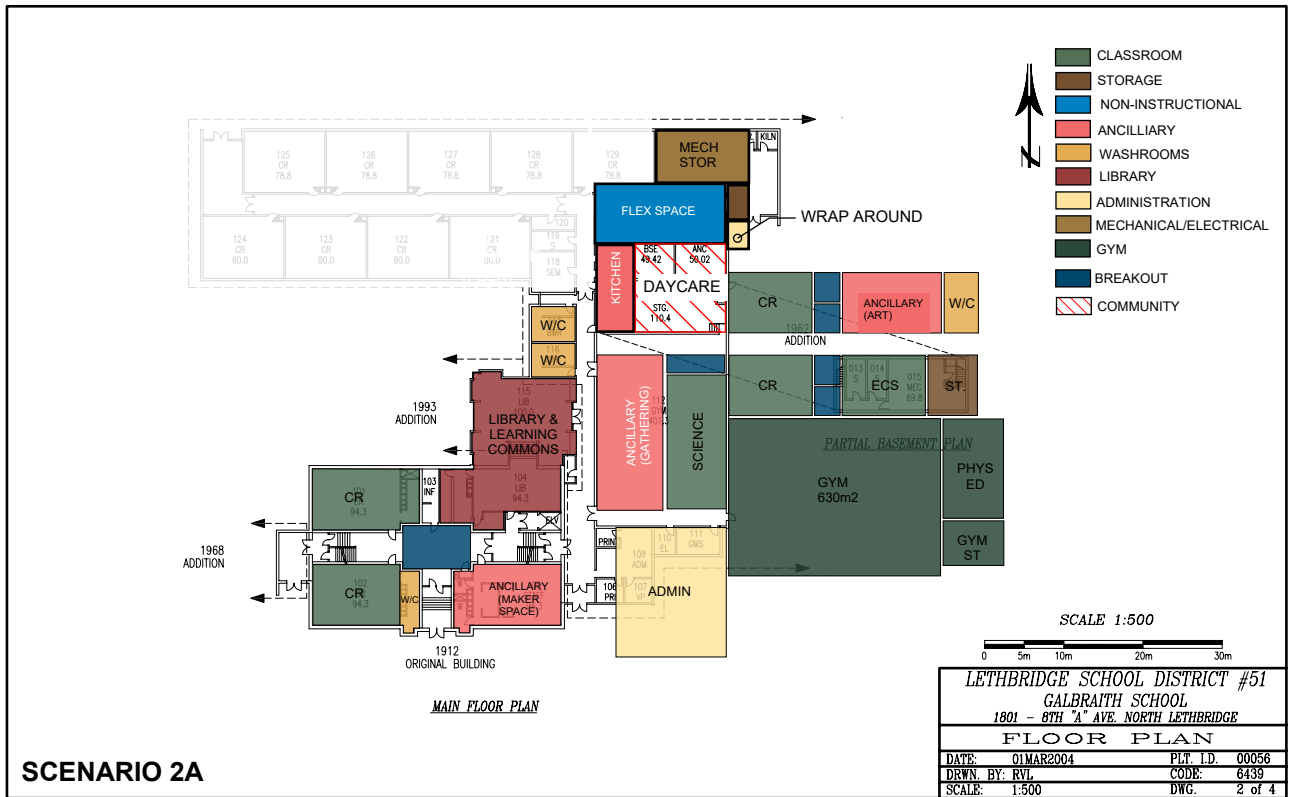
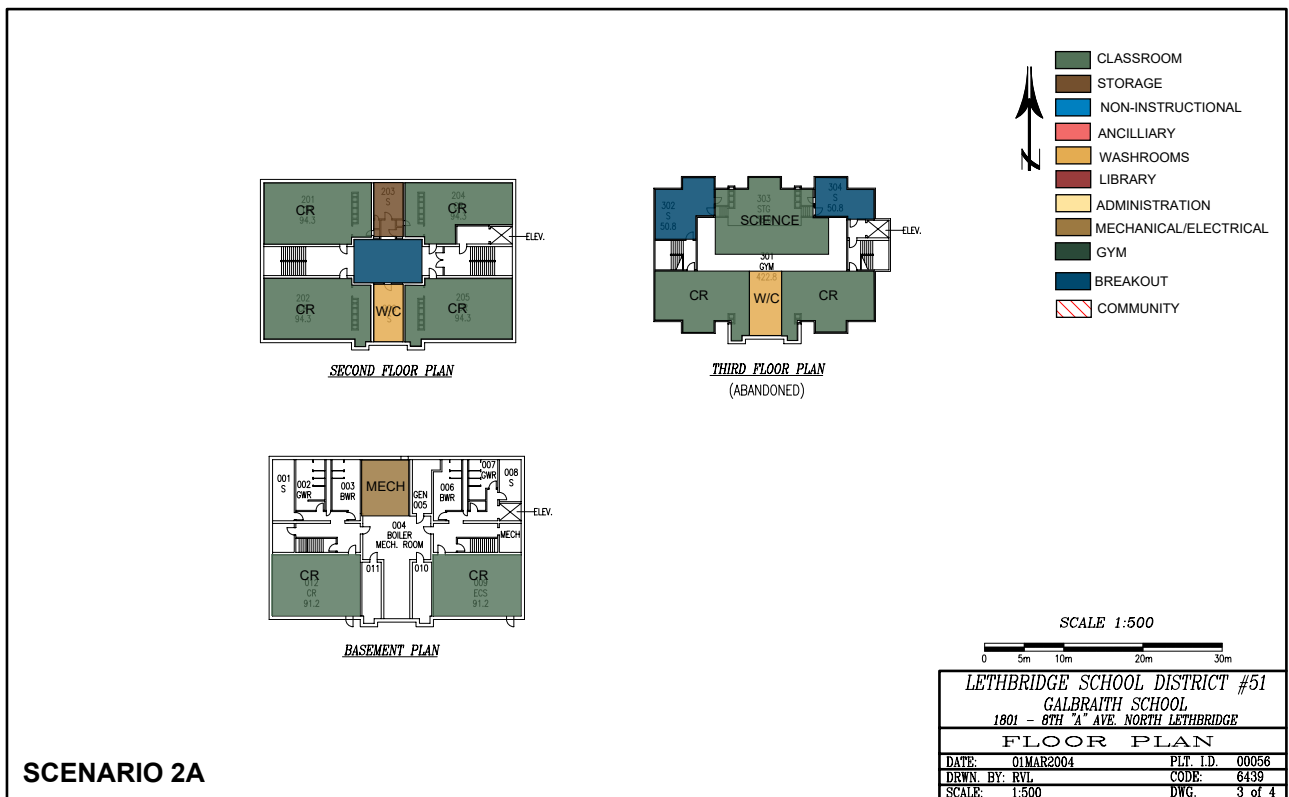
Scenario 2A

- Demolition of the exiting 1962 wing and the addition of a newly constructed 630m² gymnasium and classroom wing. The gymnasium extends into the east field of the existing school site. Towards the north of the reconstructed gymnasium there is a wing of 4 classrooms with flex and breakout spaces in between.

- The original administration space is to be replaced with a larger administration and staffroom allowing for a more spacious entrance with natural light and providing optimal visibility, alleviating the current concerns with the security and safety of students and staff.

- The third floor is reconfigured to include two classrooms as well as a bigger science room. The existing storage is utilized as breakout spaces.
- The existing classrooms on the west side of the main floor remain as classrooms with an additional washroom added.

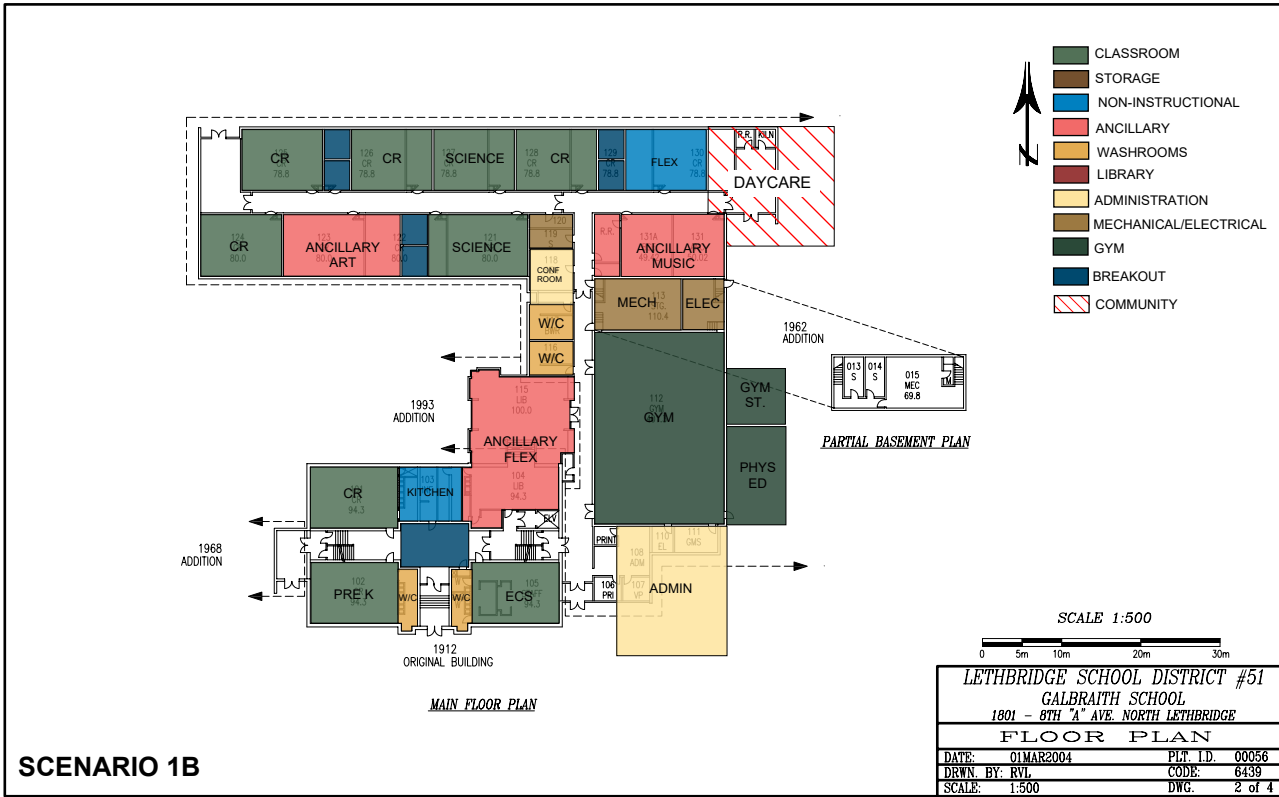
SCENARIO 1B

- This scenario renovates the existing school, keeping to the original footprint with a limited addition of gymnasium storage and a larger administration area with the opportunity for a larger front entrance with better sight lines and support space.

- Many of the existing classrooms in the 1962 remain as classrooms; however they will be reconfigured to allow for breakout rooms in between.
- A daycare addition is added to the east end of the 1962 addition.

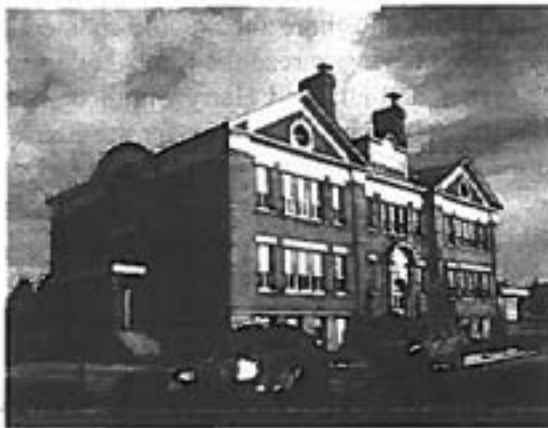
The three-storey brick Galbraith Elementary School has a hipped roof with intersecting pediment gables at each corner, a central flat roof dormer flanked by two large brick chimneys, and a classically styled main entrance with columns and a hooded curved pediment. It is located on a large schoolyard on a residential street in Lethbridge.
